Case 261 : Narrative

Case Vehicle (A): 2000 Chevrolet	Vehicle (B): 1994 GMC
Type: S10 LS, extended cab 4x2 pickup	Type: T10 Sonoma, club cab 4x4 pickup
Driver: 29-year-old female	Driver: 24-year-old male
CDC: 11-FZEW-3	CDC: 99-0000-0

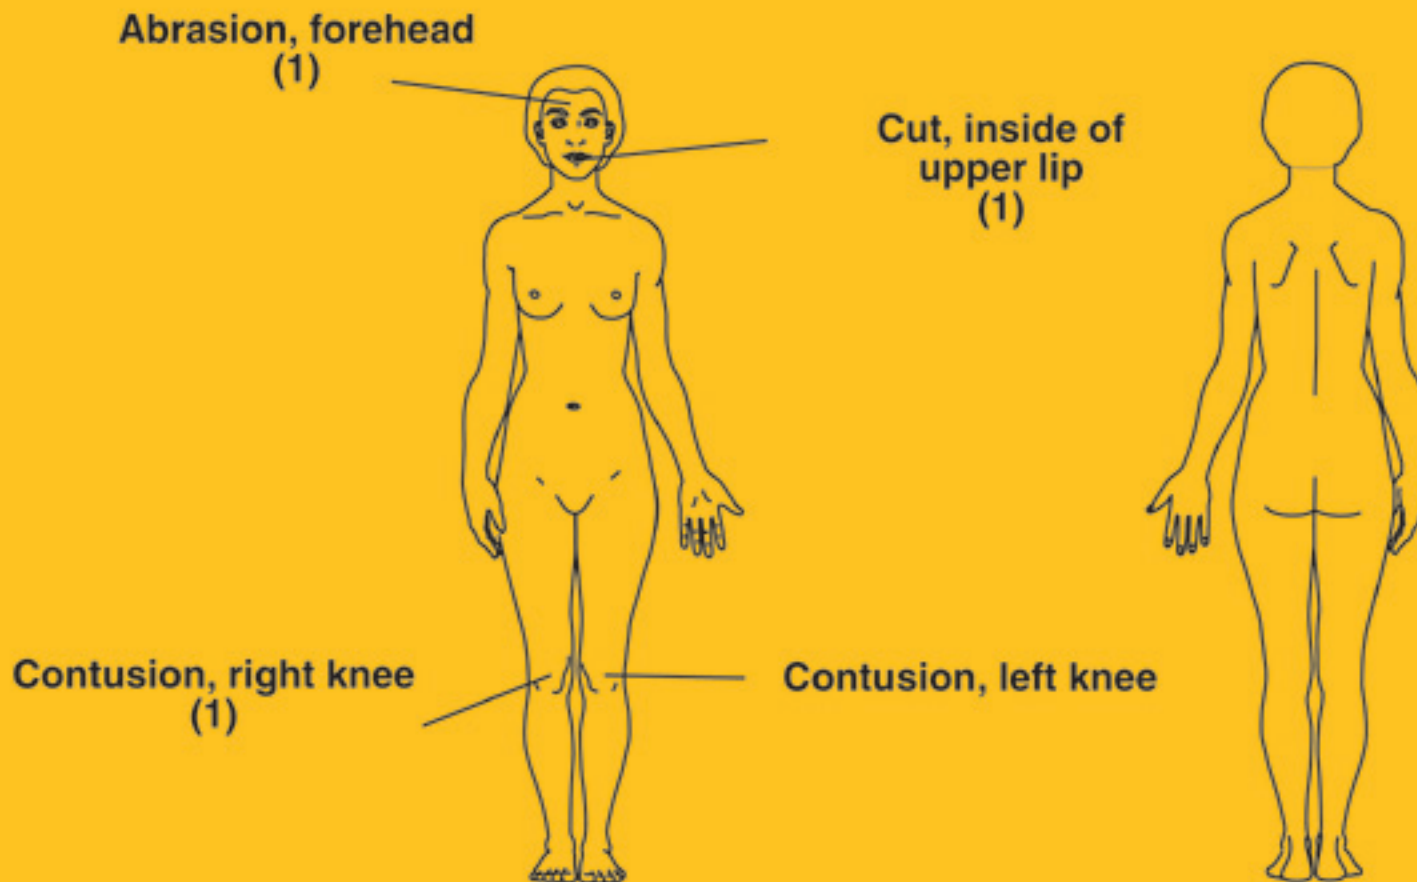
CASE NO.: 261-01

SEVERITY: MAIS - 1 ISS - 1

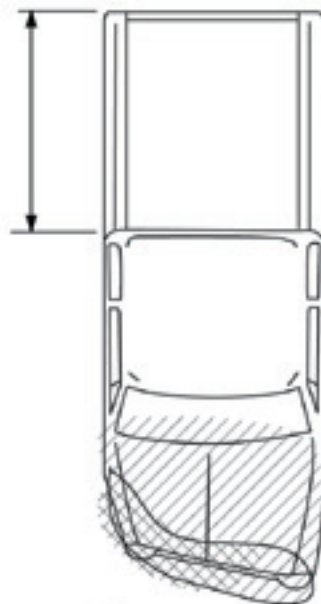
**70 cm
direct damage
max crush
50 cm at right-front
bumper corner**

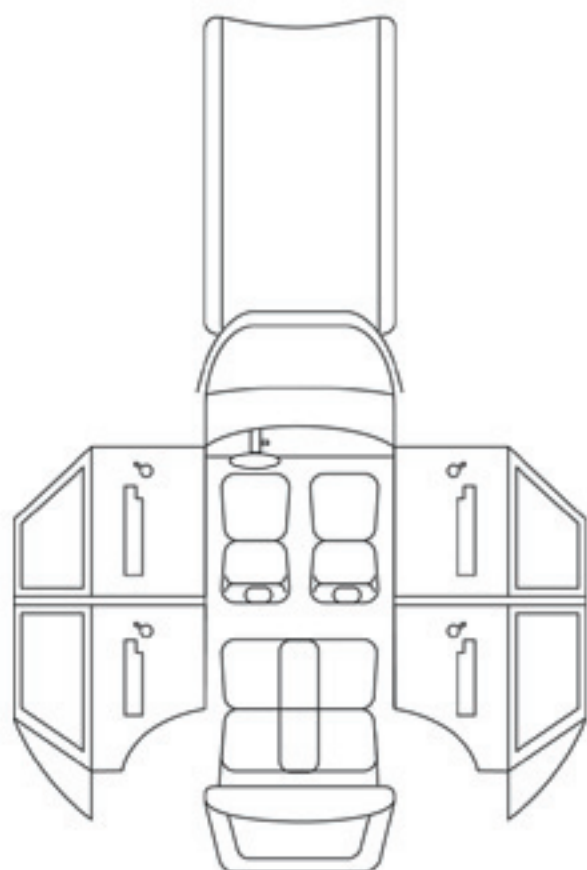
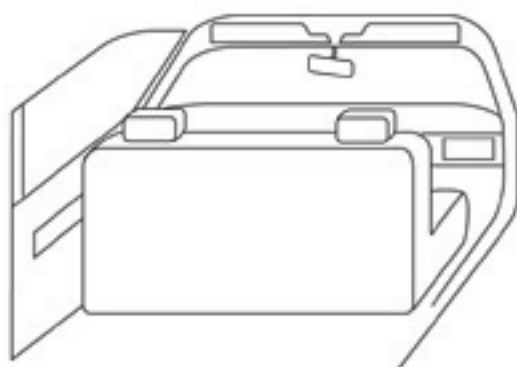
**driver belt: evidence of use -
scratches on d-ring,
plastic from D-ring on webbing,
clothing fibers on lap belt**

No shoulder-belt adjustment on B-pillar
